Chapter 3

Vegetation Communities

3.0 VEGETATION COMMUNITIES

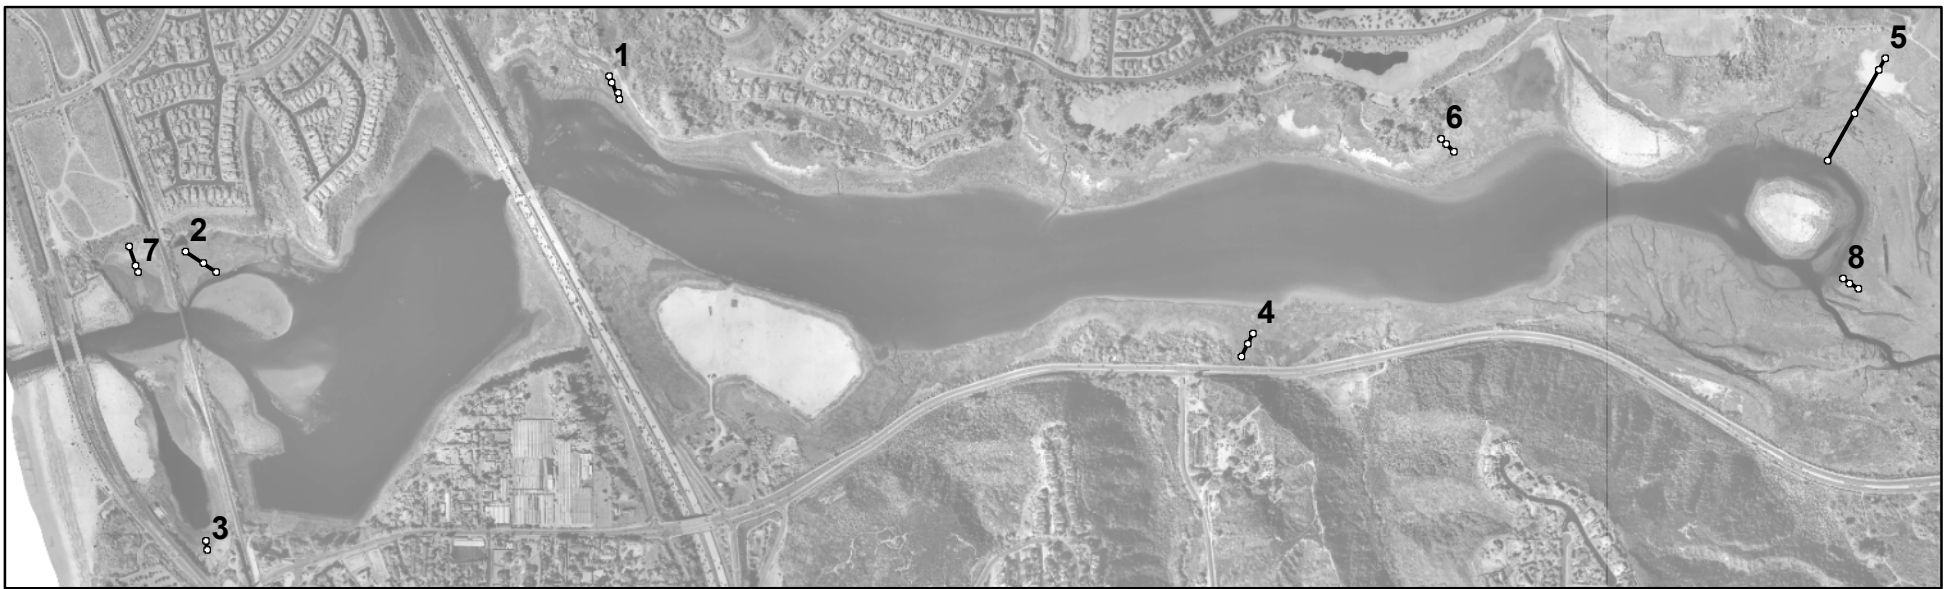
Figure 3-1

Vegetation transects and sampling locations

Eight permanent vegetation sampling sites were established during pre- and post-construction monitoring surveys (Wetlands Research Associates 1994, 1997) (Figure 3-1). The same sites and methodology were utilized during annual post-restoration vegetation monitoring conducted in early fall of 1997, 1998, 1999, 2001, and 2006. At each site, a baseline transect was established perpendicular to the shoreline. Points were established along each baseline within each marsh zone (high, middle, and low). At each point, a 20-meter fiberglass measuring tape was extended away from the baseline, parallel to the shoreline. The coordinates for the transects are listed in Appendix A3-1. A photograph of the site was taken each year to further document changes over time.

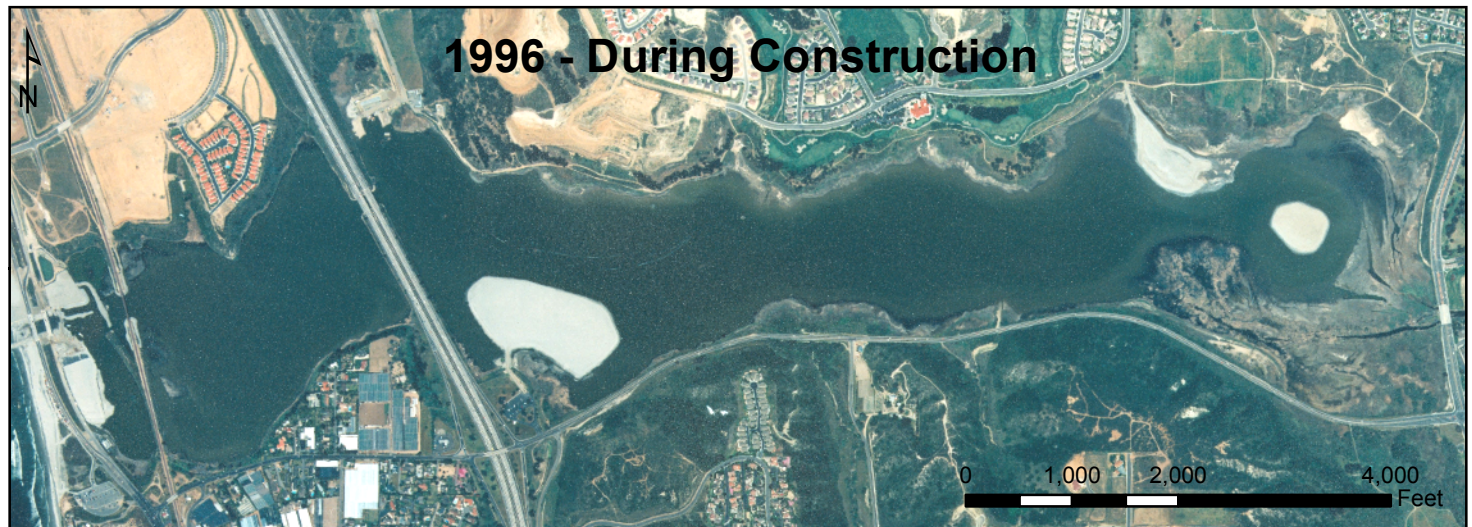
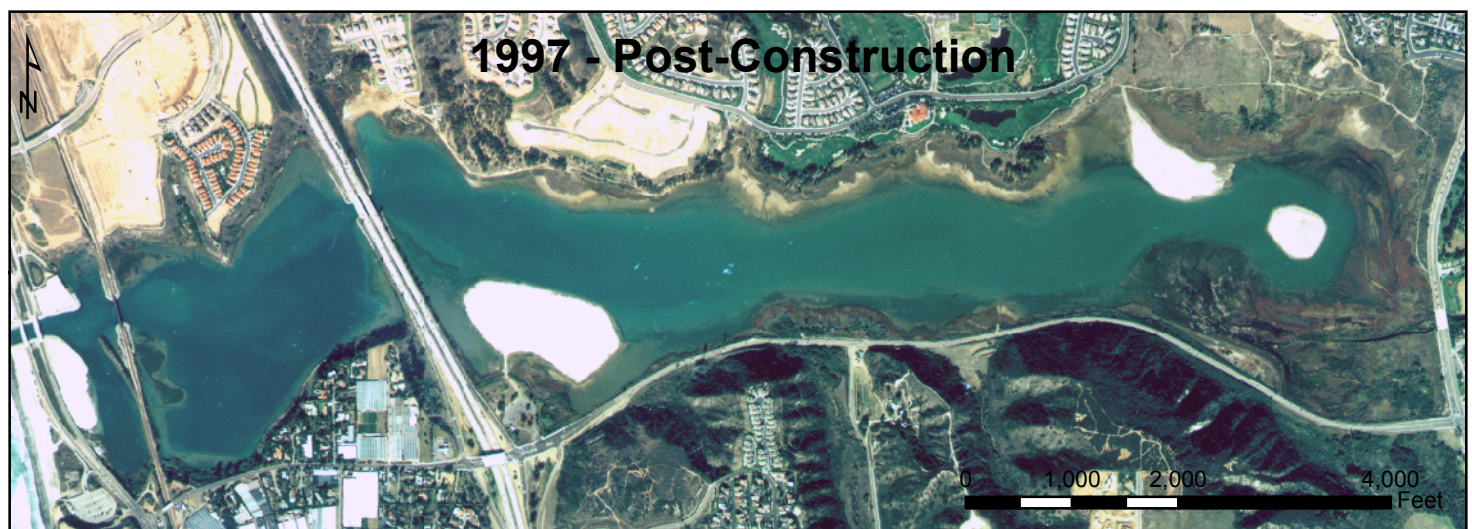
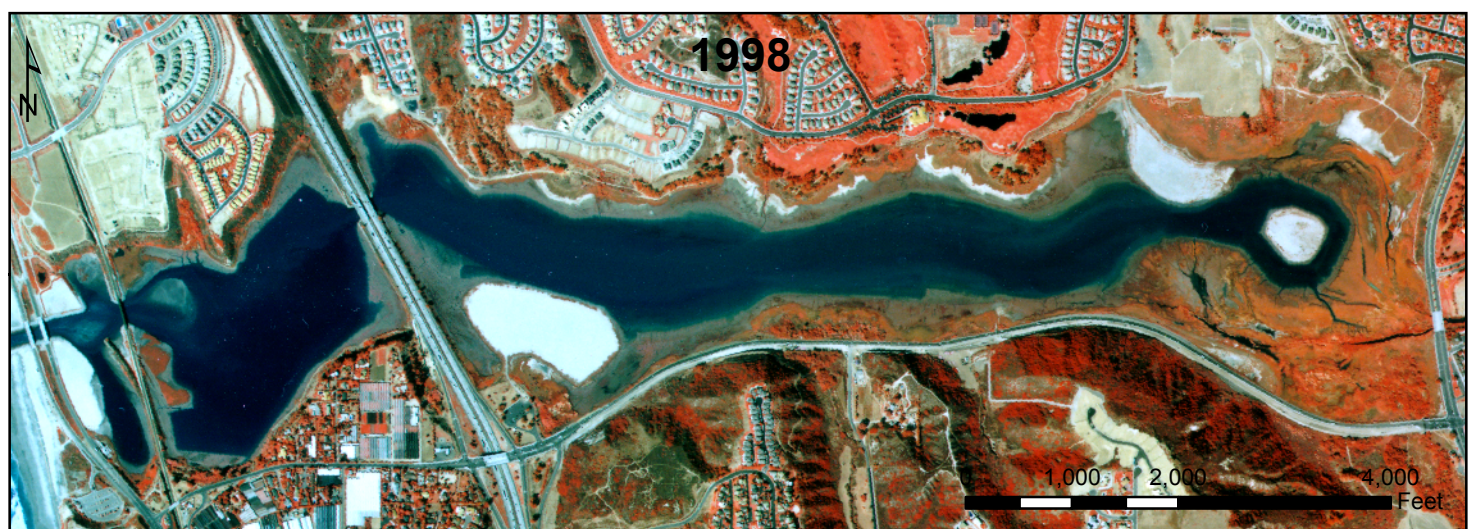
Figure 3-2a

**Annual aerial images of Batiquitos Lagoon
during construction (1996) and post-construction (1997 and 1998)**

Figures 3-2a, b, and c present the color aerial imagery collected over the 10-year monitoring period. The imagery provides an overview of the changes in the surrounding urban development and physical features of the lagoon, as well as sediment accretion and the development of various habitats. Notable changes year to year include additional housing built to the north of the central and east basins, the portion of the central basin flood shoal removed in the 2003 dredging, the developing morphology of tidal channels, the infilling of the subtidal area surrounding the island nesting site (E-3) at the east end of the lagoon, the expansion of eelgrass (*Zostera marina*) over time, and the development of other vegetation communities as described below.

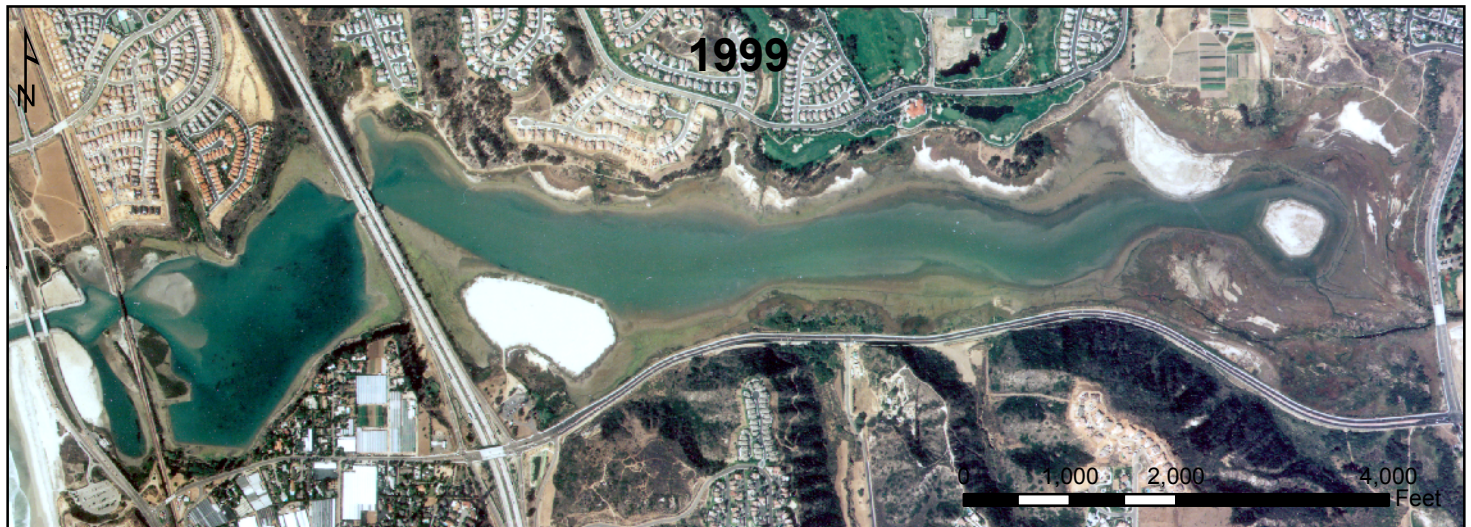
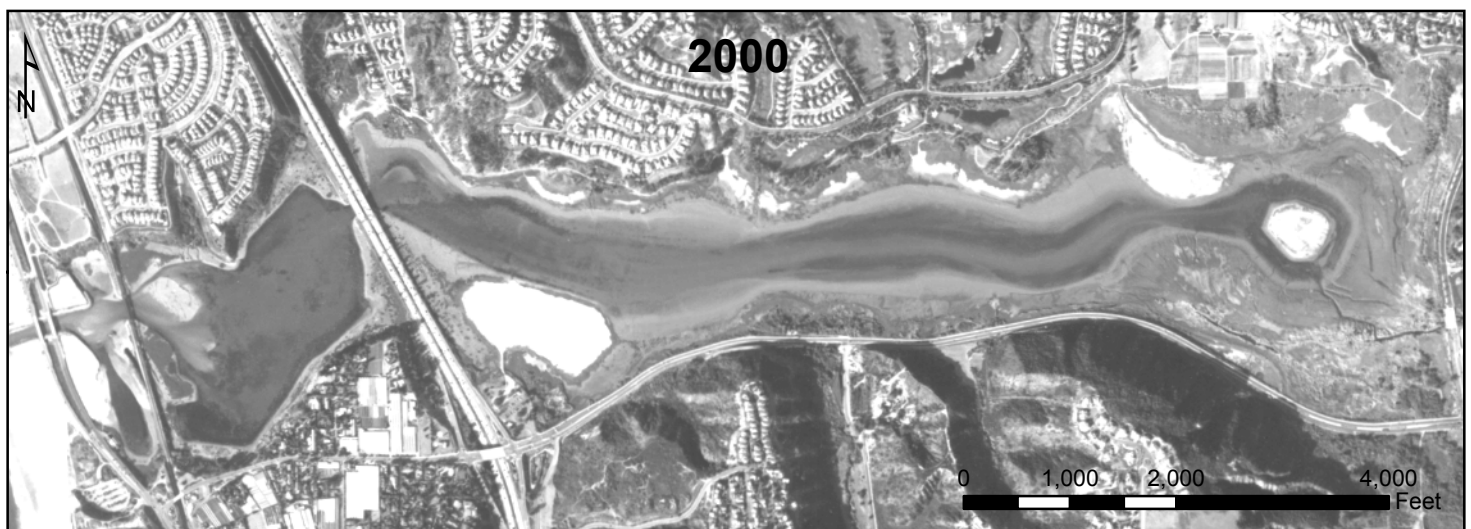
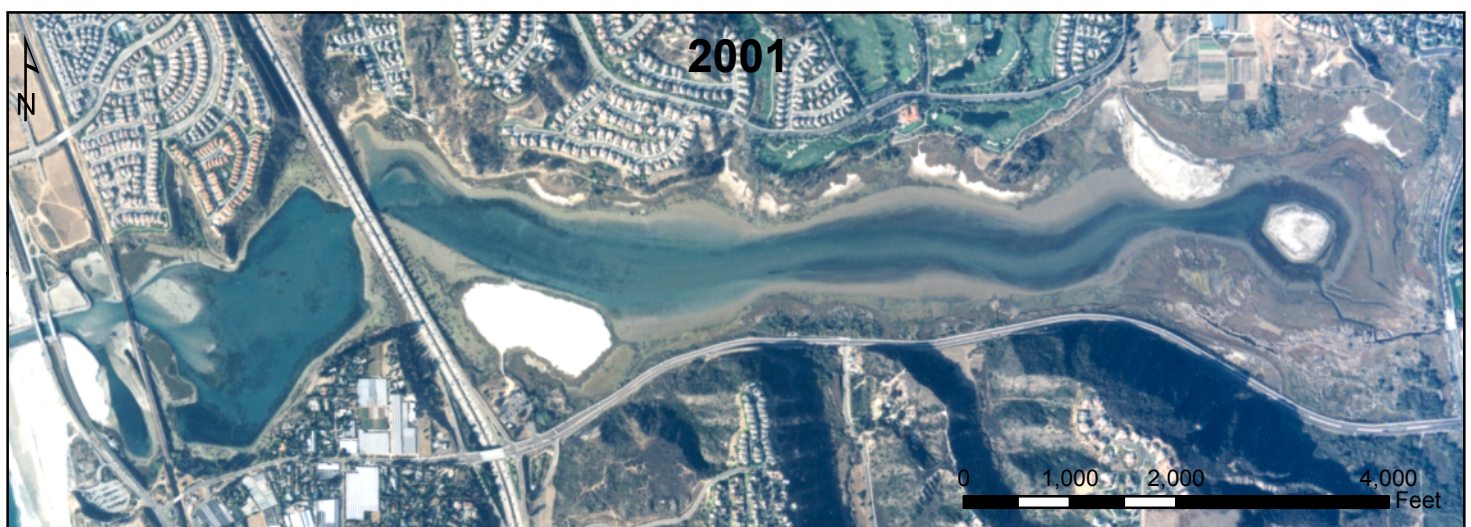
Figure 3-2b

**Annual aerial images of Batiquitos Lagoon
(1999, 2000, & 2001)**

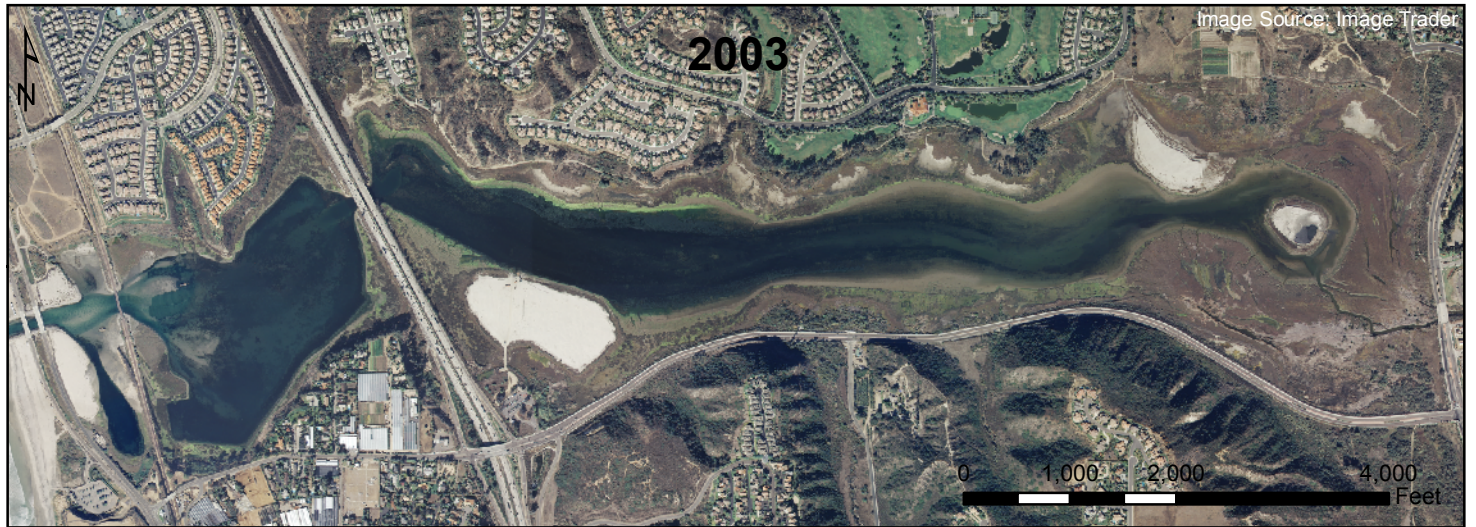
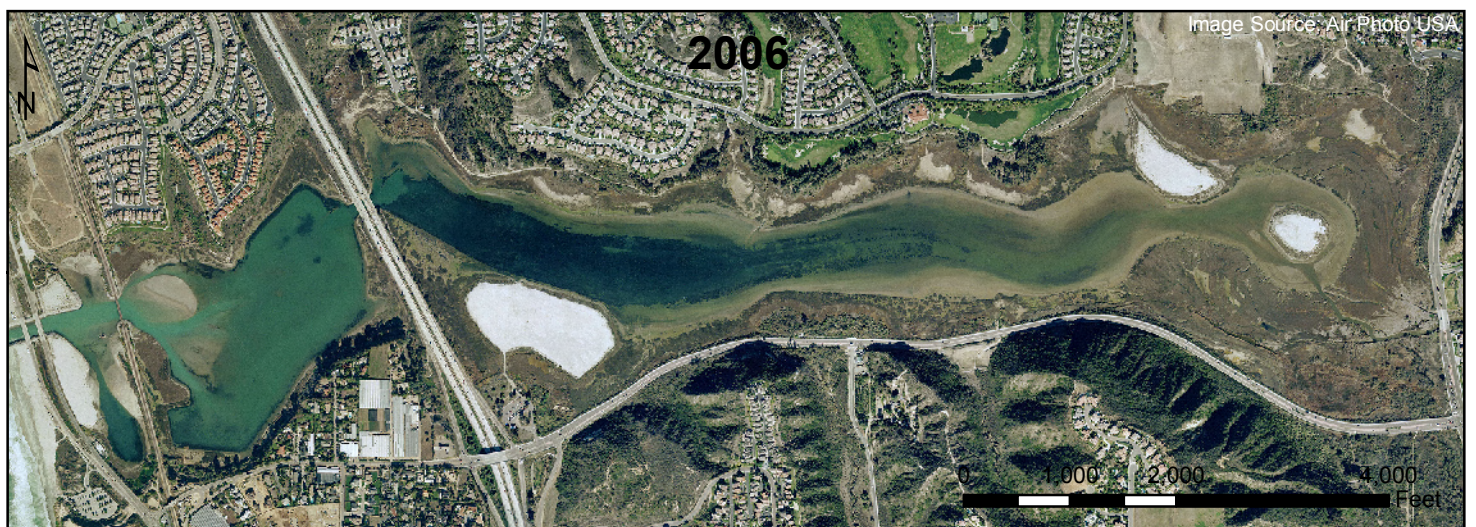
Figure 3-2c

**Annual aerial images of Batiquitos Lagoon
(2003, 2005, & 2006)**

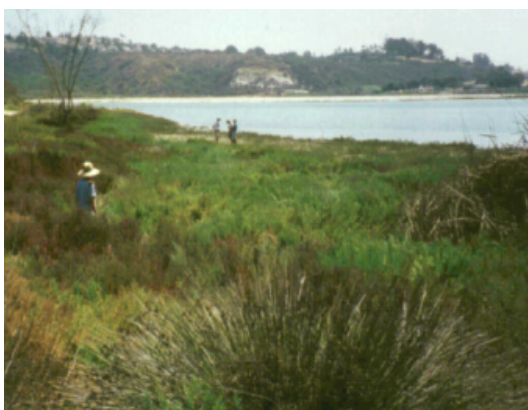
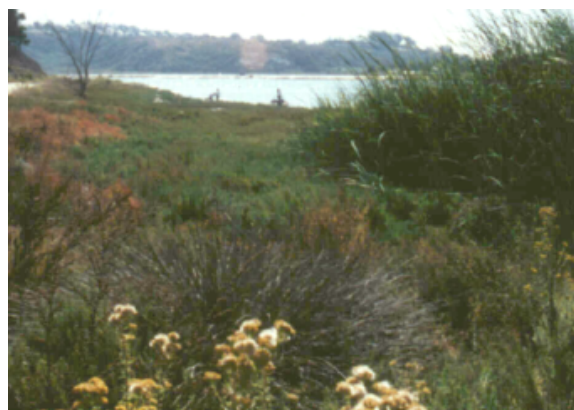
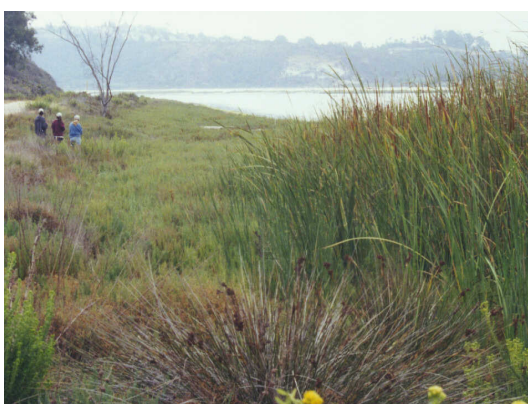
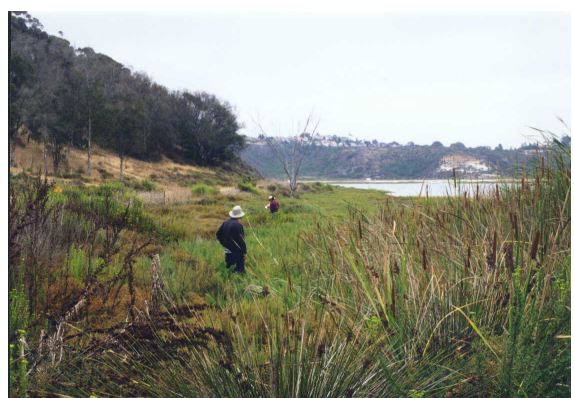
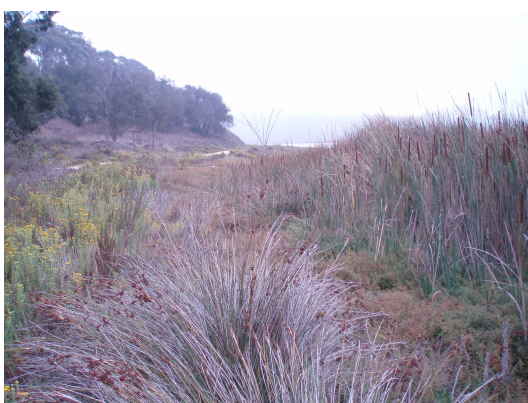
Figure3-5a

**Vegetation transect, site 1
pre-restoration (1994 and 1996)
and post-restoration (1997-2006)**

Figures 3-5a through 3-5h illustrate the changes in the vegetation community with photographs taken at fixed locations at each transect monitoring site during pre-restoration (1994 and 1996) and post-restoration (1997 to 2006) years.

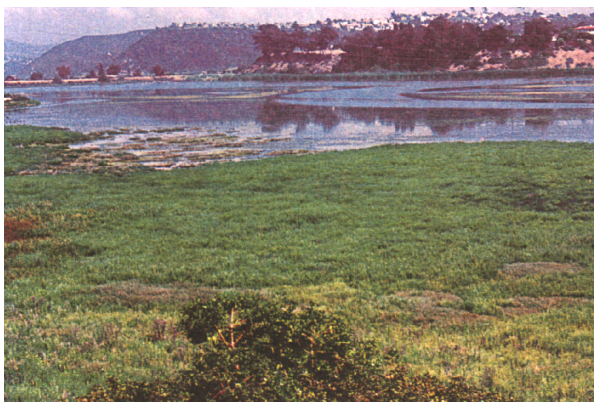
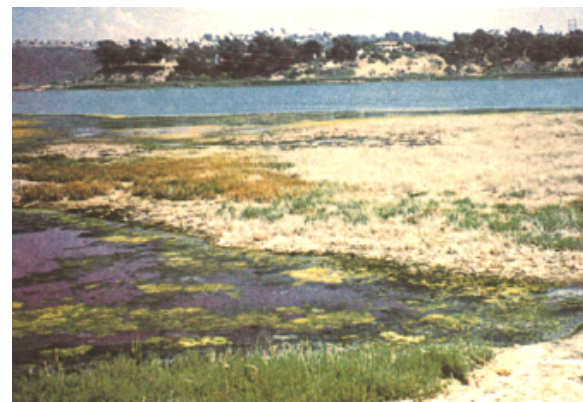
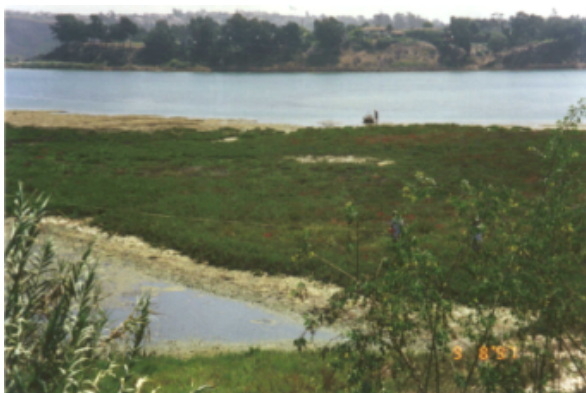
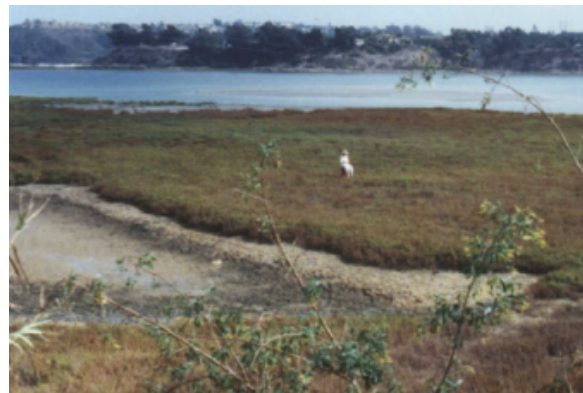
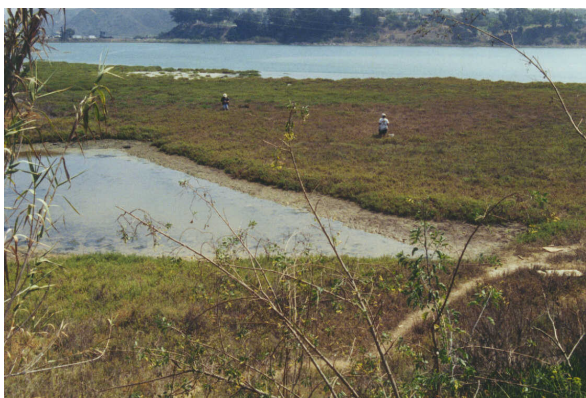
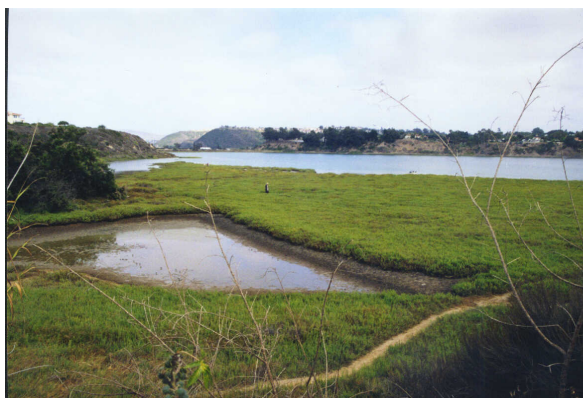
Figure3-5b

**Vegetation transect, site 2
pre-restoration (1994 and 1996)
and post-restoration (1997-2006)**

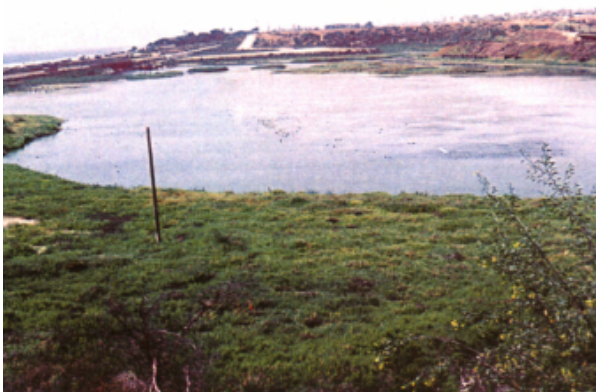
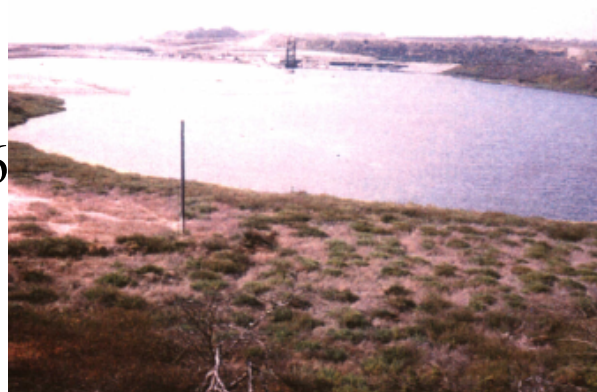
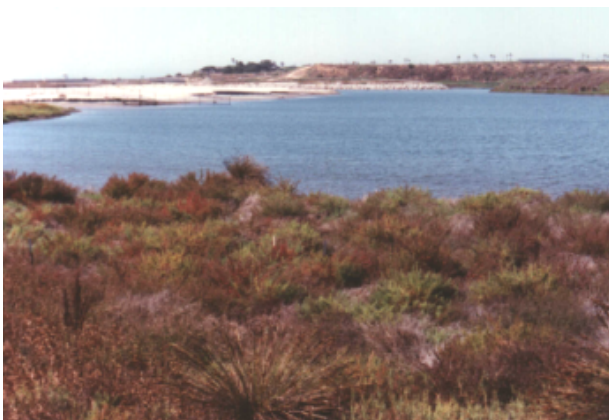
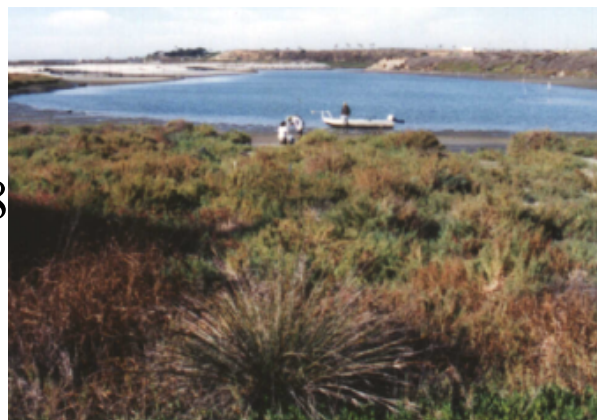
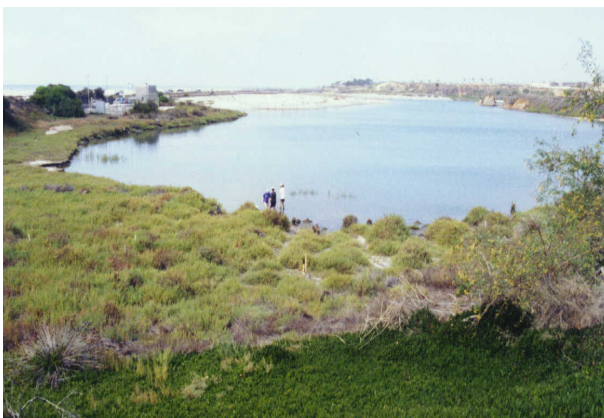
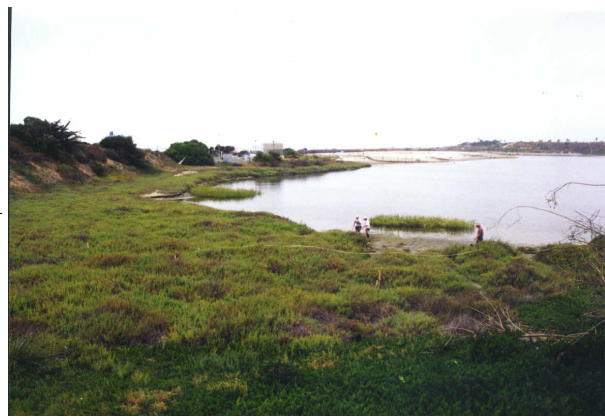
Figure3-5c

**Vegetation transect, site 3
pre-restoration (1994 and 1996)
and post-restoration (1997-2006)**

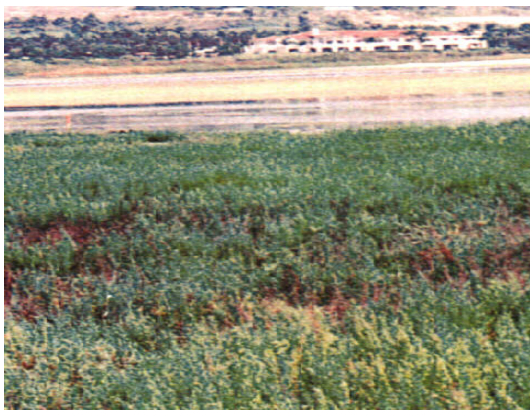
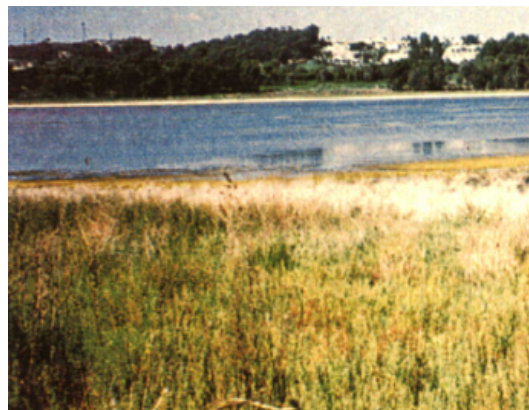
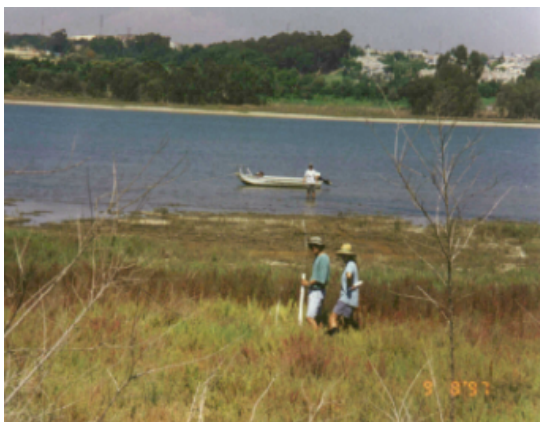
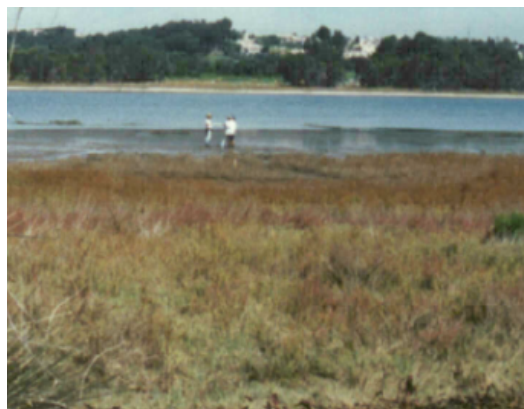
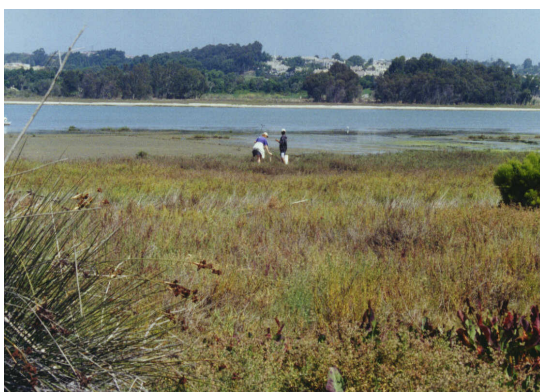
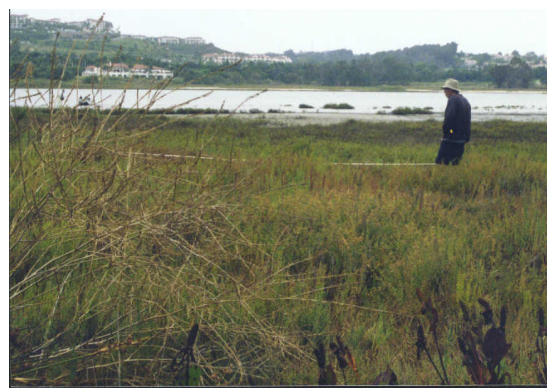
Figure3-5d

**Vegetation transect, site 4
pre-restoration (1994 and 1996)
and post-restoration (1997-2006)**

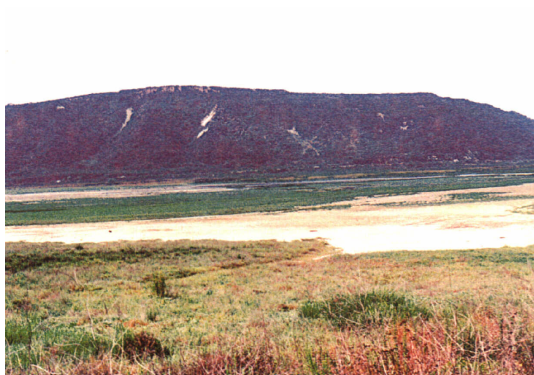
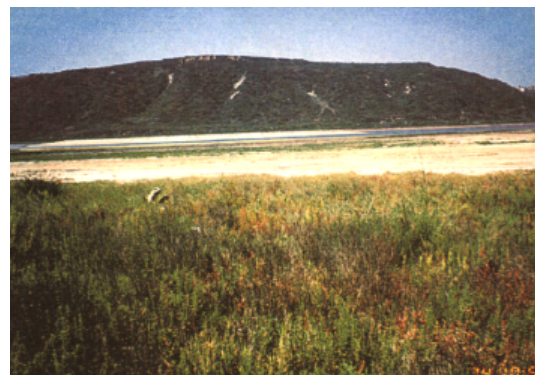
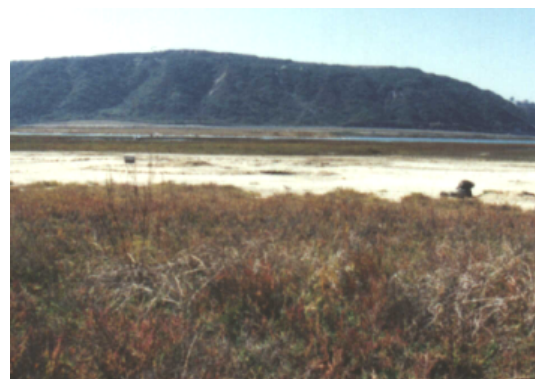
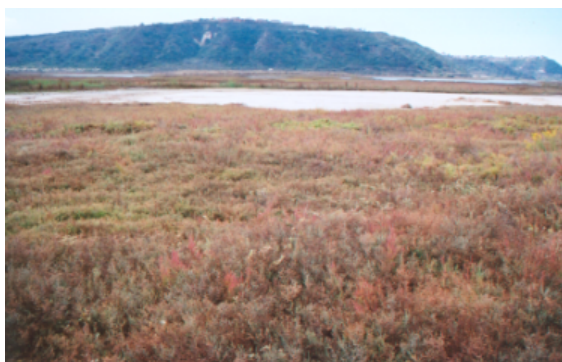
Figure3-5e

**Vegetation transect, site 5
pre-restoration (1994 and 1996)
and post-restoration (1997-2006)**

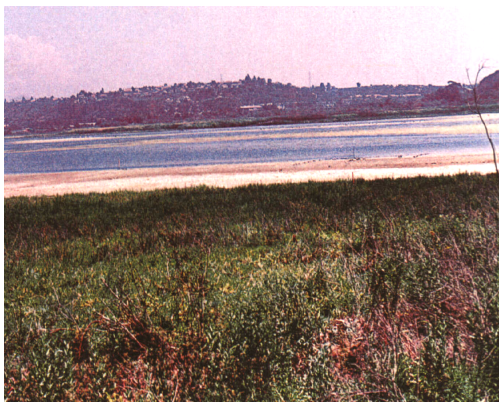
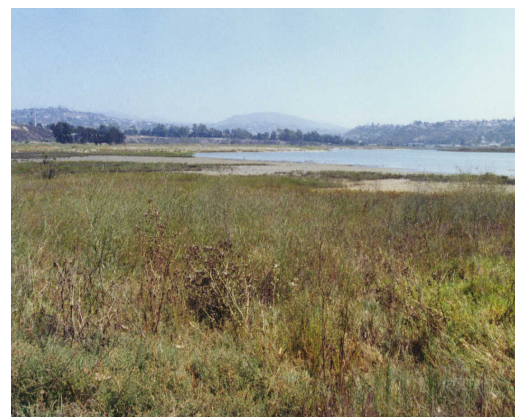
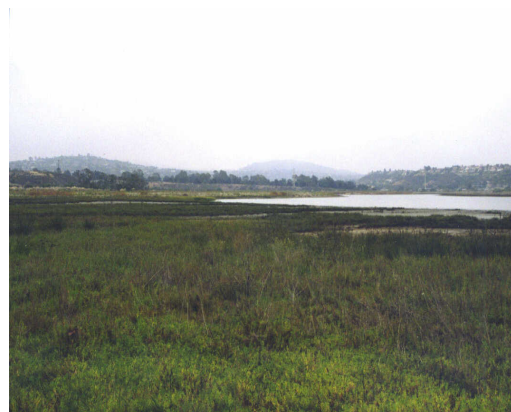
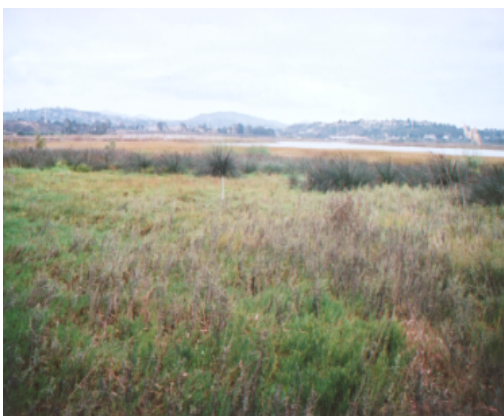
Figure3-5f

**Vegetation transect, site 6
pre-restoration (1994 and 1996)
and post-restoration (1997-2006)**
